Faringdon Road, Swindon
A Vision For Shopfront And Façade Enhancements
Final Report : April 2023

Will Holborow

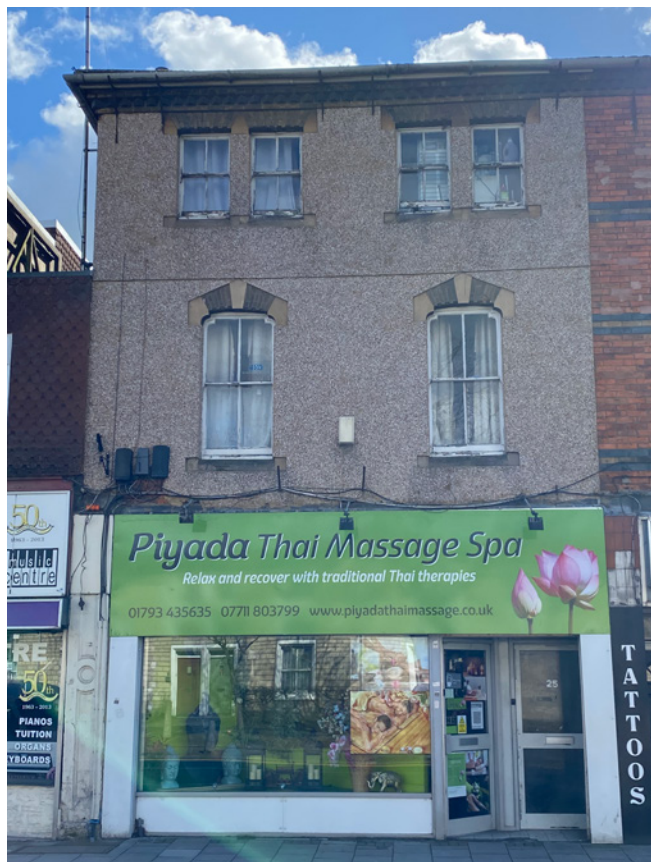
No.25 Faringdon Road. One of the most altered façades, having a modern shopfront, aluminium door to the upper floors and rendered upper floors.

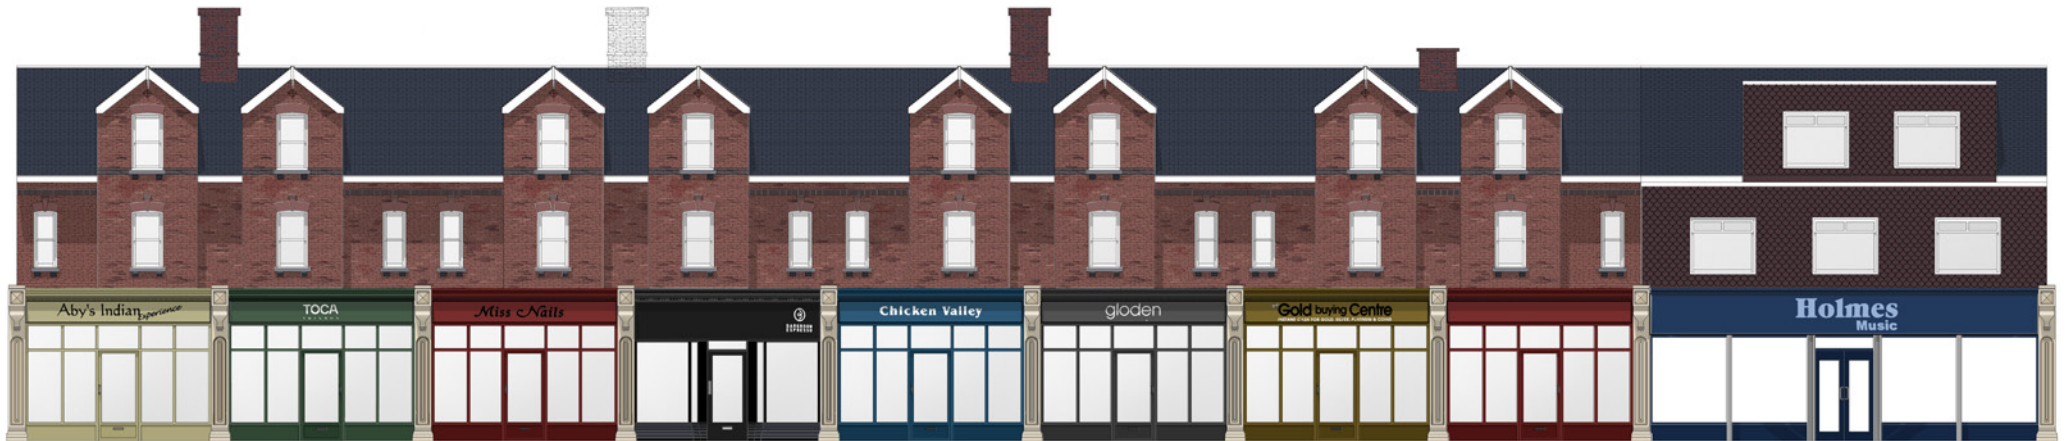
Visualisation of 5–23 Faringdon Road showing reinstatement of traditional shopfronts to the whole terrace with two exceptions - No.11 which has a recently installed shopfront - and Nos.21-23 (Holmes Music) which has a modern frontage dating from the 1970s.

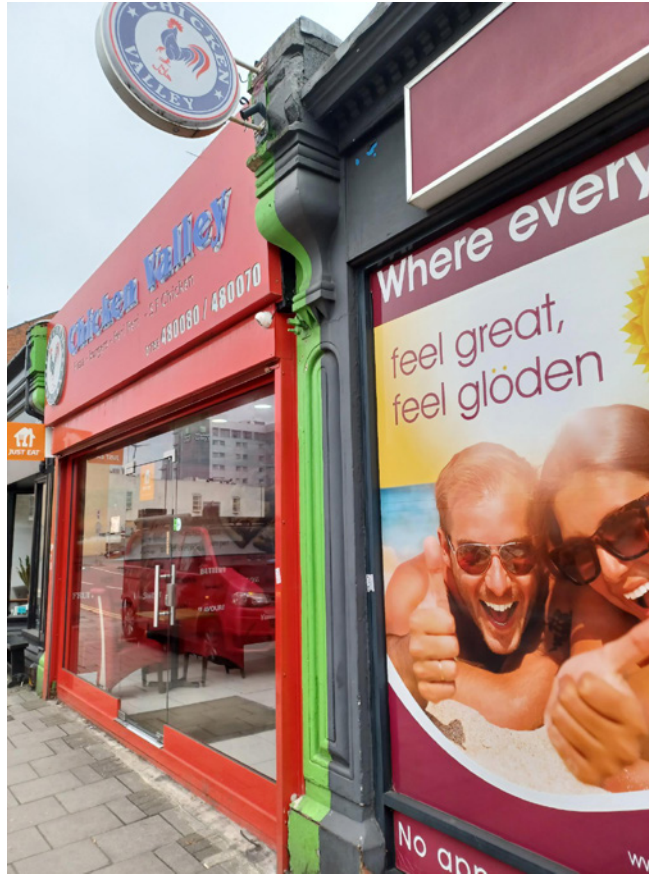
The painting of a pilaster in different colours undermines its visual unity

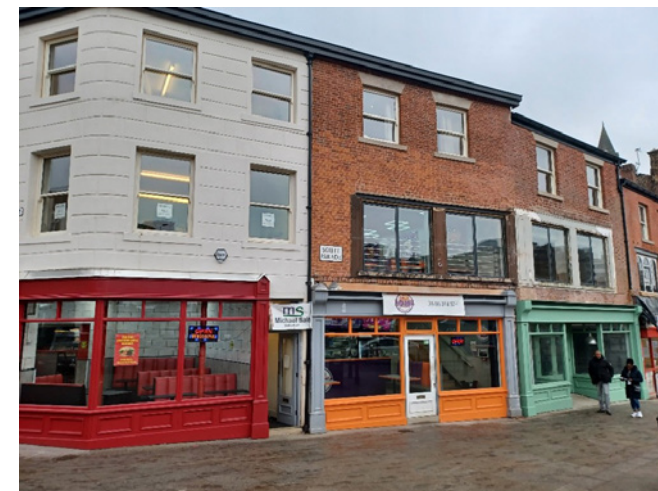
Newly installed shopfronts in Rochdale (April 2022) using a contemporary colour palette

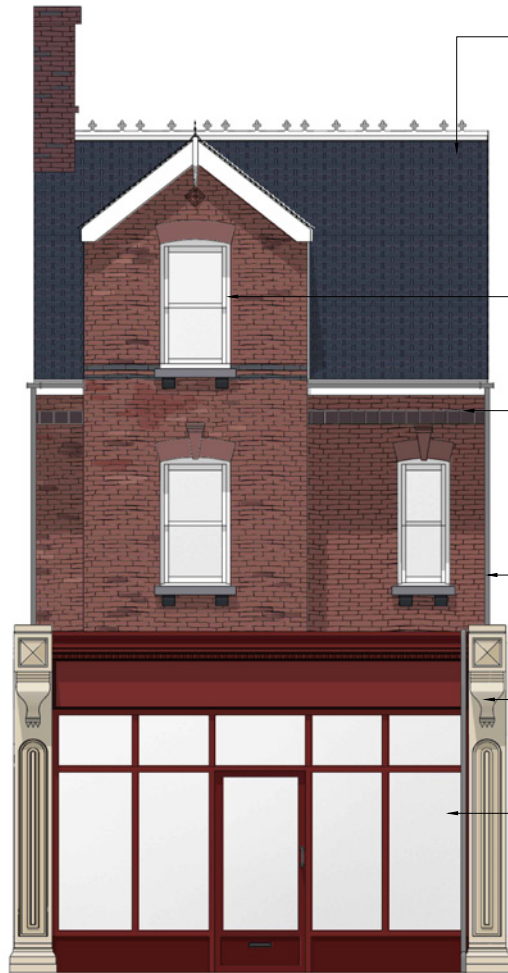
Annotated Elevations Showing Architectural Features

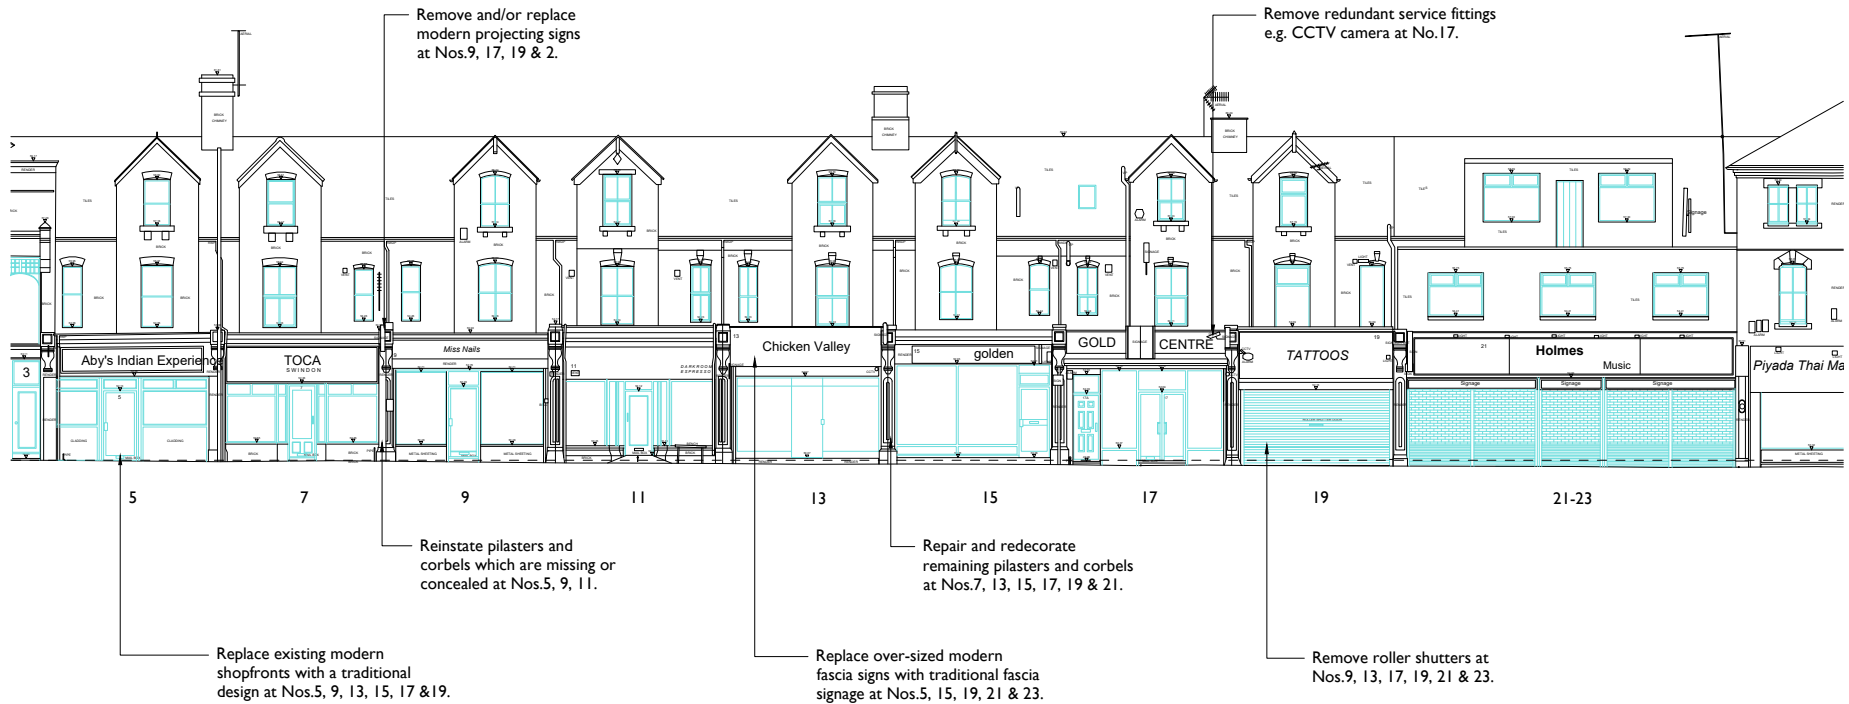
- All properties:
- Tidy up trailing wiring and electrical conduits.
 - Investigate rainwater pipework.

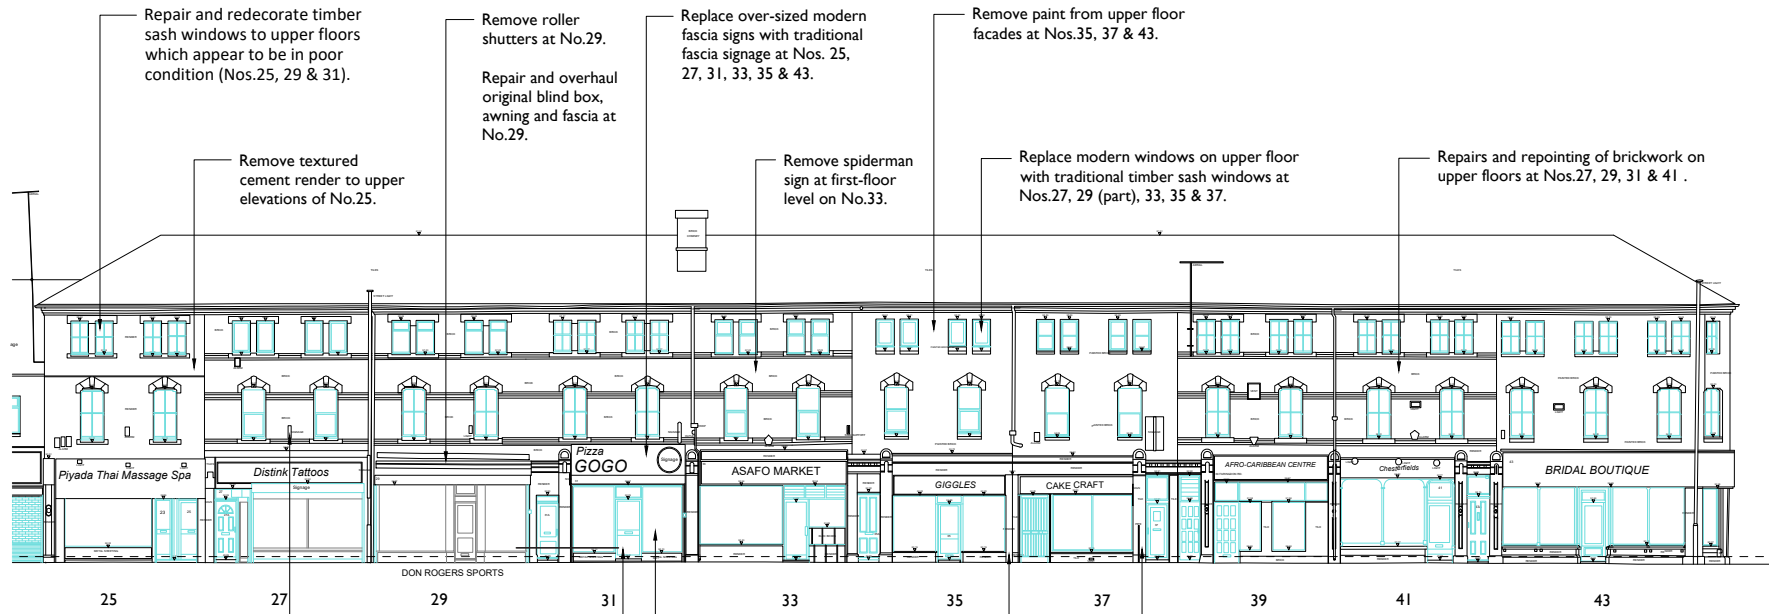
- All properties:
- Repair and redecorate remaining pilasters and corbels.
 - Tidy up trailing wiring and electrical conduits.
 - Remove redundant service fittings and hanging brackets.
 - Replace all gutters and grey plastic downpipes with cast-iron to match originals.

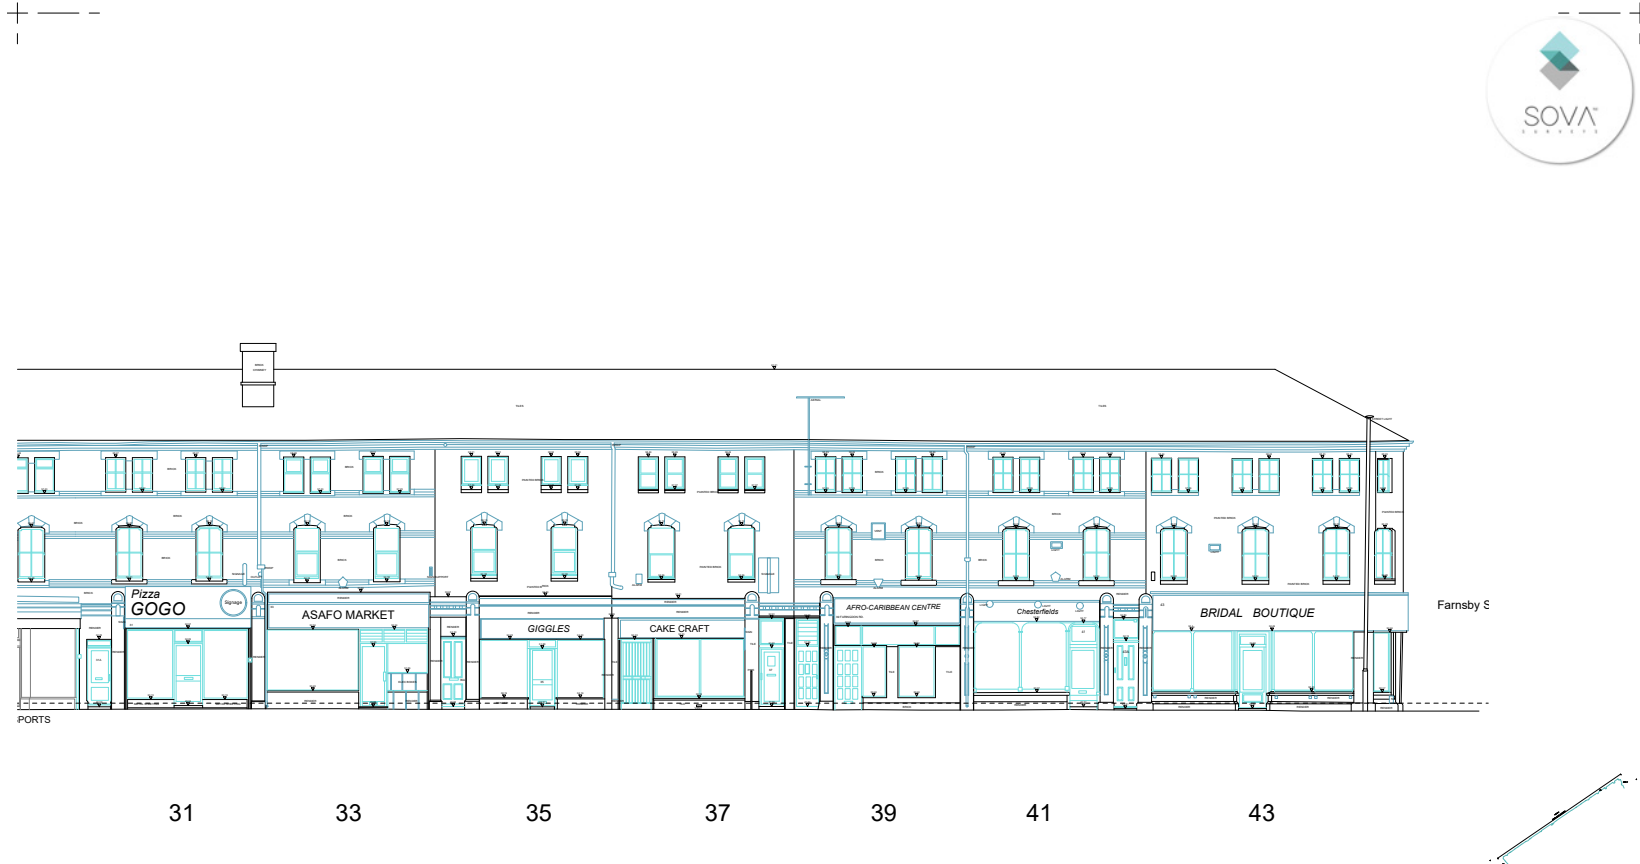
Existing Frontages as Recorded by Sova Surveys (Scale 1:50 AT A1)

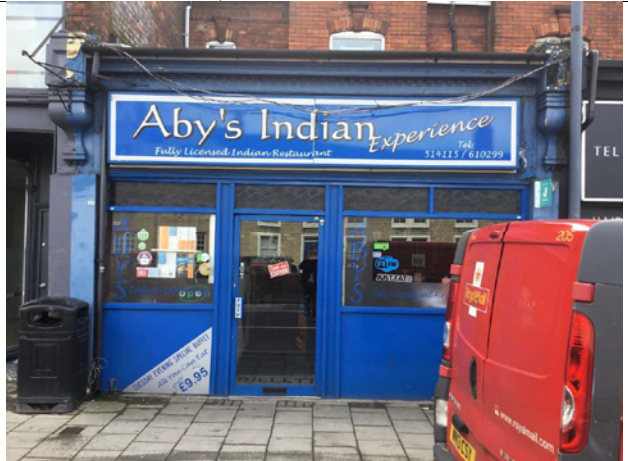
Current shop name:	Aby's Indian

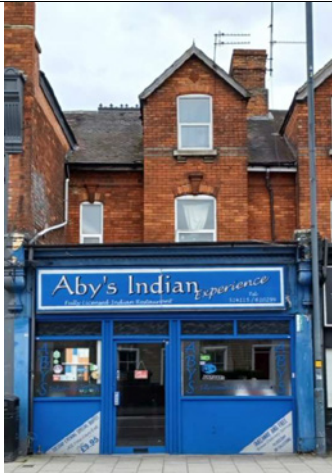
Current appearance (April 2022)

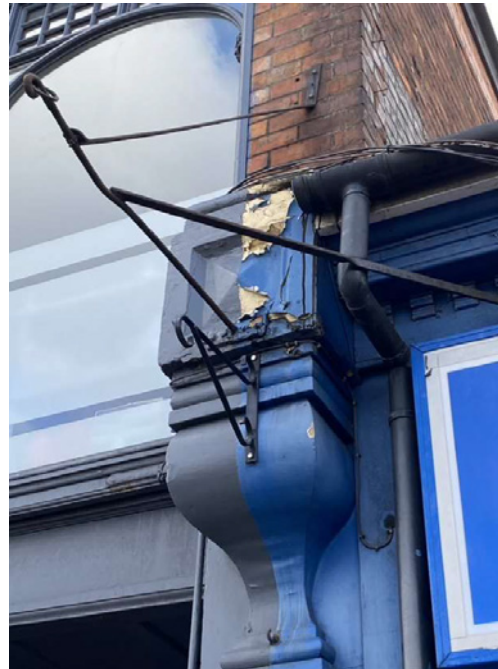
Left side corbel demonstrating peeling paint. The upper bracket is of some historic interest and is unique to the terrace. The lower bracket is a modern addition.

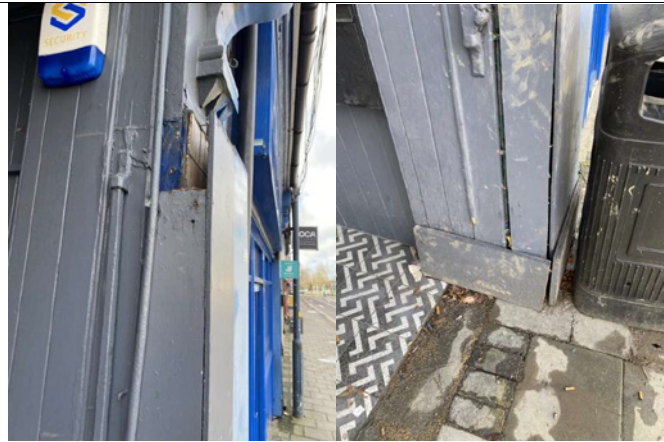
Left side pilaster obstructed by previous interventions – including boarding, tiling and boxed out with timber. Boxed out timber is deteriorating, particularly at the bottom. Street furniture (black plastic waste bin) is unsightly and obstructs features.

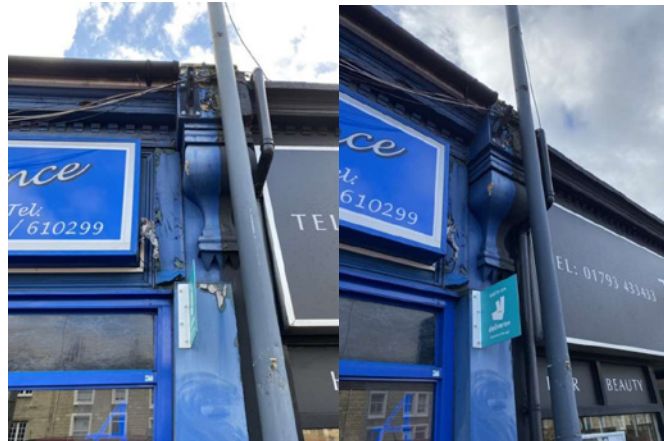
Right side corbel showing peeling paint, redundant metal bracket, obstruction of street lamp post and deteriorating timber of fascia.

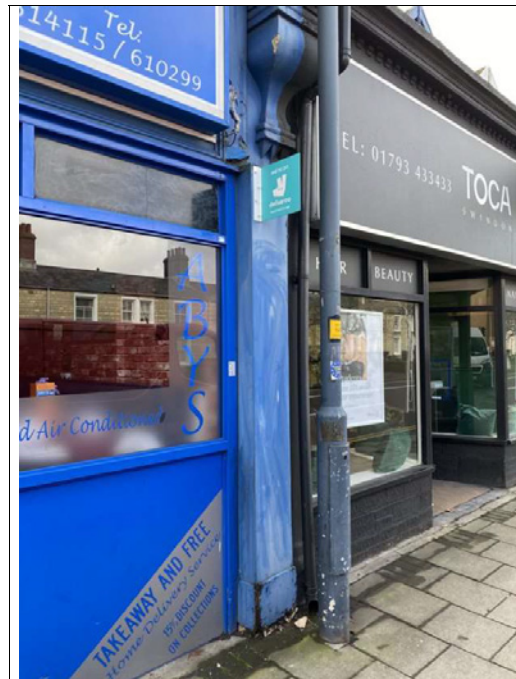
Timber boxing over original pilaster feature. Minor deterioration to bottom corners.

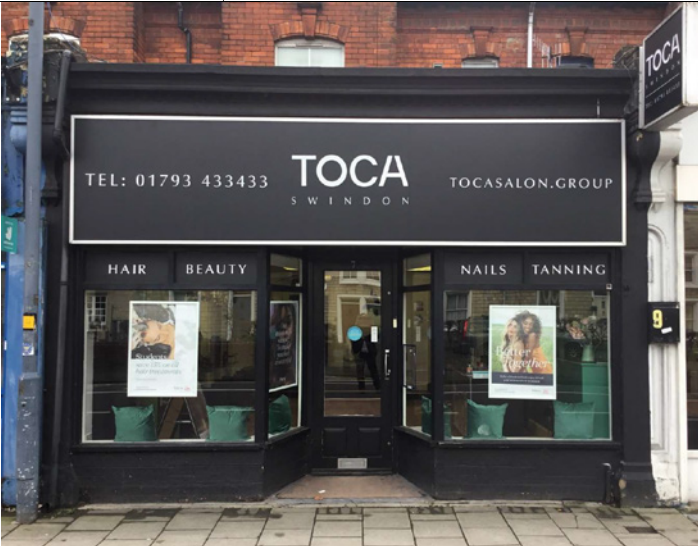
History and Significance	Shown on the 1 st edition OS map (1885) as a house with an open front garden, part of a terrace (Nos.5 – 23), noted as 'Queen Anne's Buildings'. Soon after the front area was developed as a single-storey shop, which remains with an altered shopfront. The building and terrace as a whole have architectural and historic interest, as explained in the summary report ('Faringdon Road, Swindon: A Vision for Shopfront and Façade Enhancements'). The facade makes a positive contribution to the character and appearance of Swindon's Railway Conservation Area.
Brief Description of Shopfront	Modern shopfront within original pilasters, corbels and dentilled cornice.
Brief Description of Upper Floors	Upper floors set back and form a group (Nos. 5 – 19). Brickwork and replacement windows.

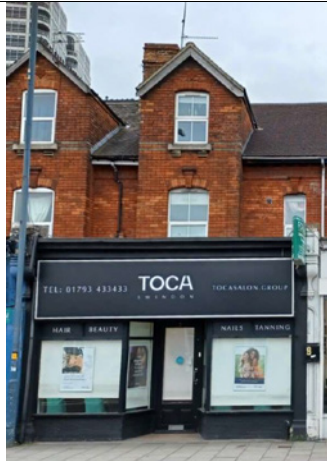
Current appearance (April 2022)

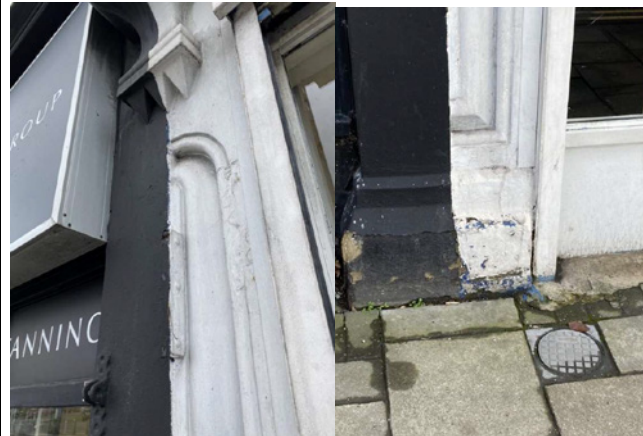
Photo showing delamination of the bottom of the pilaster and infill of the pilaster moulding.

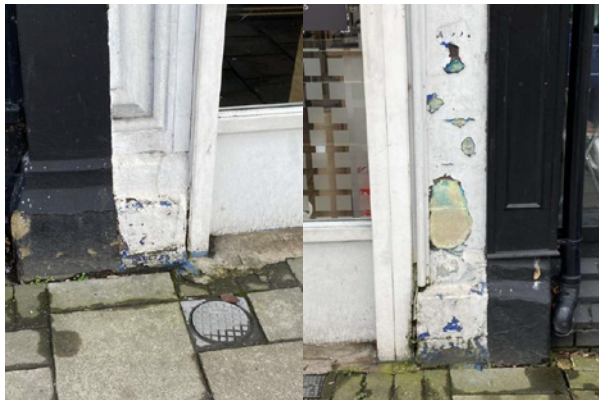
Left – deterioration of base of left-side pilaster.

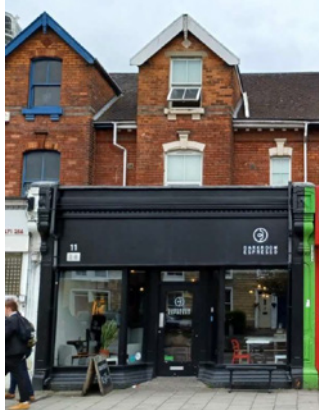
Current appearance (April 2022)

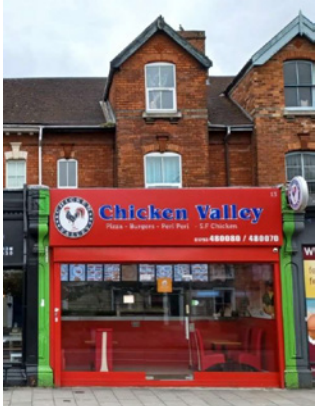
<p>Current appearance (April 2022)</p>
Condition of Property	
Roof	<p>Concrete tile roof.</p>
Facade	<p>Red brick with contrasting band of buff brick and terracotta details to eaves, window heads and gable.</p>
Upper Floor Windows	<p>Modern replacements</p>
Shopfront	<p>1. Large oversize fascia sign, covering over all cornice details</p>

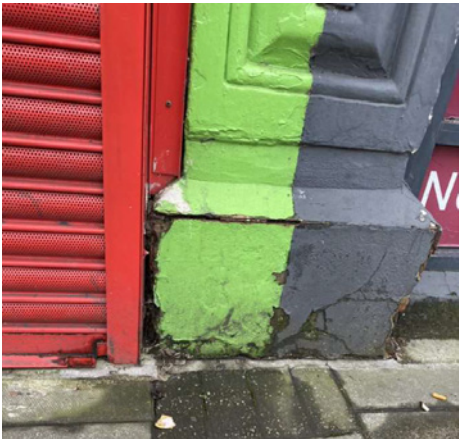
Photo showing deterioration of base of pilaster.

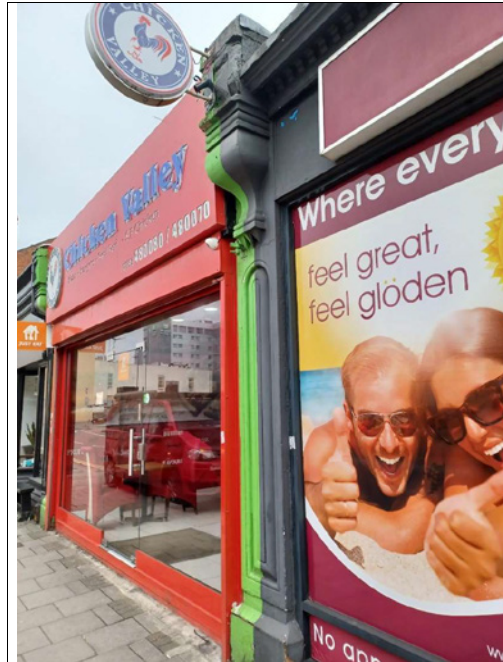
Photo showing projecting sign fixed into corbel through redundant sign bracket.

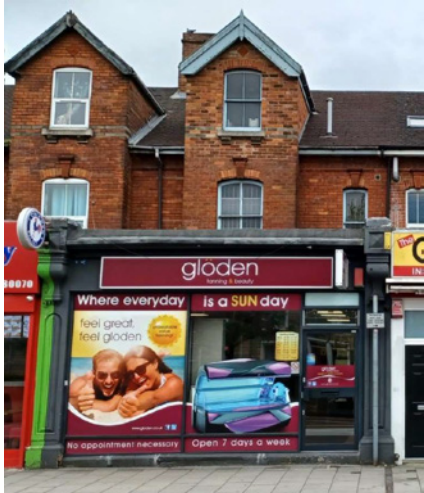
</div> <p>Current appearance (April 2022)</p>
Condition of property	
Roof	Concrete tile roof.
Facade	Red brick with contrasting bands of buff brick and terracotta details to eaves, window heads and gable.
Upper Floor Windows	Original timber sash windows
Shopfront	<ol style="list-style-type: none"> Large windows with oversize marketing images Paint peeling from the fascia not covered by plastic box signage Untidy roof covering detail over corbels. Left side corbel has deteriorated and lost definition of moulding Bottom of pilasters deteriorating

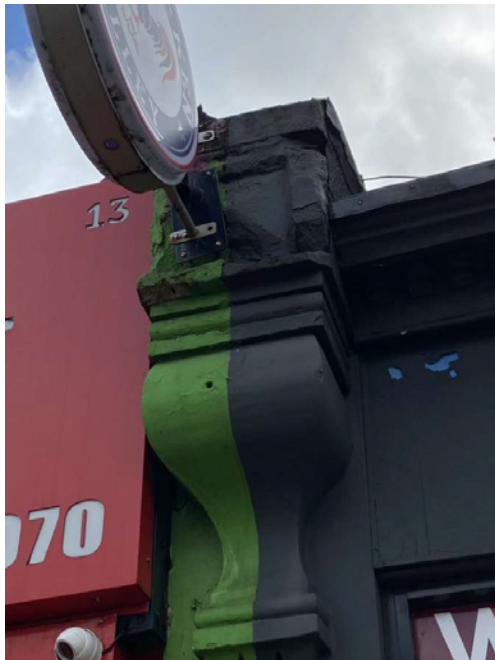
Deteriorated top of corbel over left side pilaster

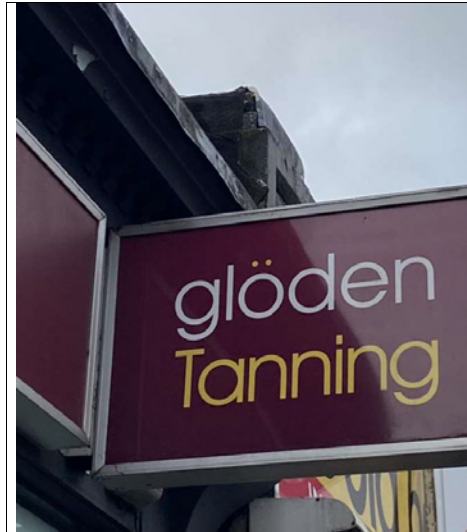
Aluminium box signs to fascia and projecting sign.

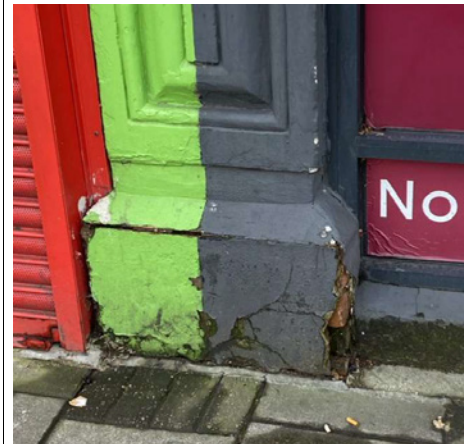
Base of left side pilaster deteriorated.

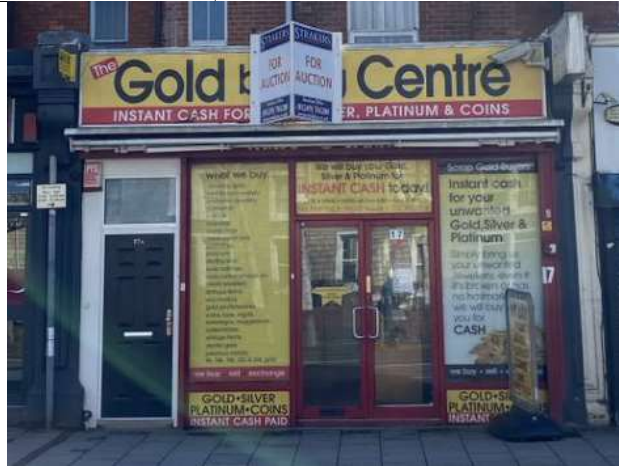
Current Shop Name	Former Gold Buying Centre
--------------------------	----------------------------------

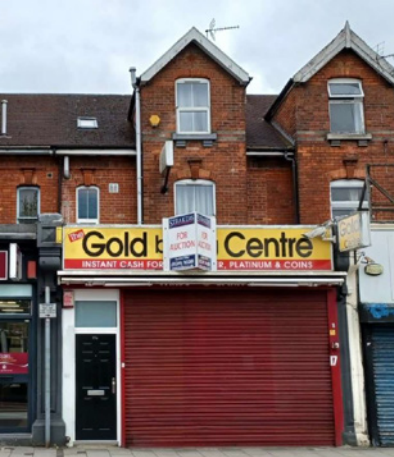
Condition of Property	
Roof	Concrete tile roof.
Facade	Red brick with contrasting bands of buff brick. Terracotta details to eaves, window heads and gable. Projecting sign at first-floor level. Burglar alarm box on gable at second-floor level.
Upper Floor Windows	Replacement modern windows.

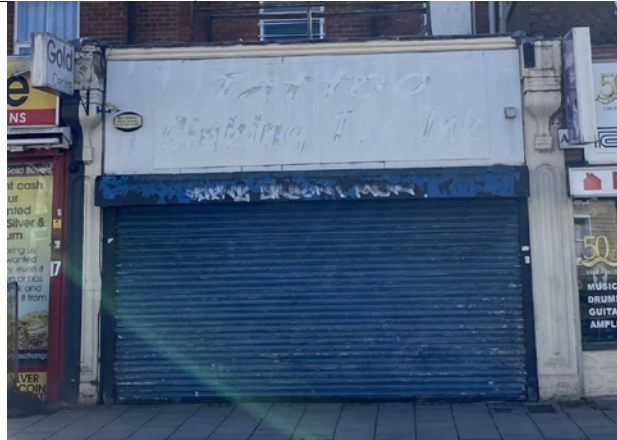
Photo of the existing shopfront with roller shutter down

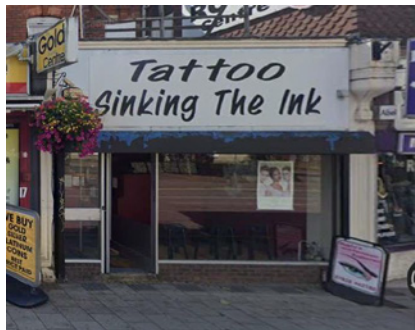
2018 photo (Google StreetView)

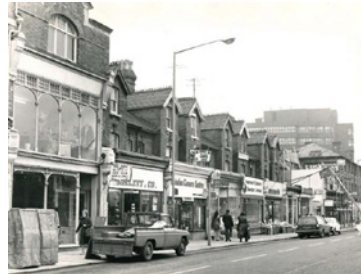
<p>1976 photo of Faringdon Road shows flat-roofed extension being added to Nos.21-23.</p>

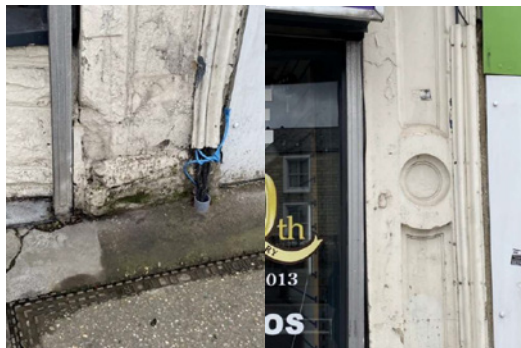
Left photo - Deteriorating lower pilaster (right side). Right photo - Cabling running over the pilaster surface and deteriorating surface condition (right side)

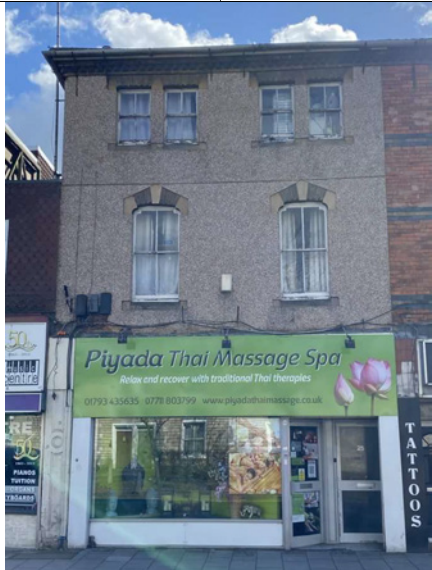
History and significance	Shown on the 1 st edition OS map (1885) as the end-of-terrace property (Nos.25 – 43). The building and terrace as a whole have architectural and historic interest, as explained in the summary report ('Faringdon Road, Swindon: A Vision for Shopfront and Façade Enhancements'). Having a much altered façade, there is high potential to enhance the appearance of this property by repairing, revealing and restoring original features. This would also enhance the character and appearance of Swindon's Railway Conservation Area.
Brief Description of Shopfront	Modern shopfront, deep fascia. Roller shutter across front, plastic pilasters and stall riser. Metal shop window and door frames. Metal door. Tiled floor covering to entrance. No original features of the shopfront were visible.

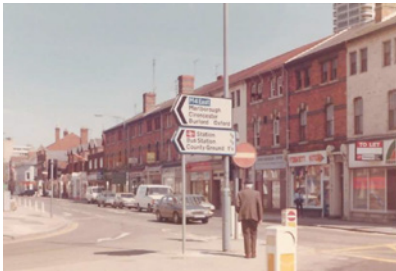
<p>In this photo of 1986 the façade of No.25 (just visible to the left of the image) was not yet rendered.</p> </div>

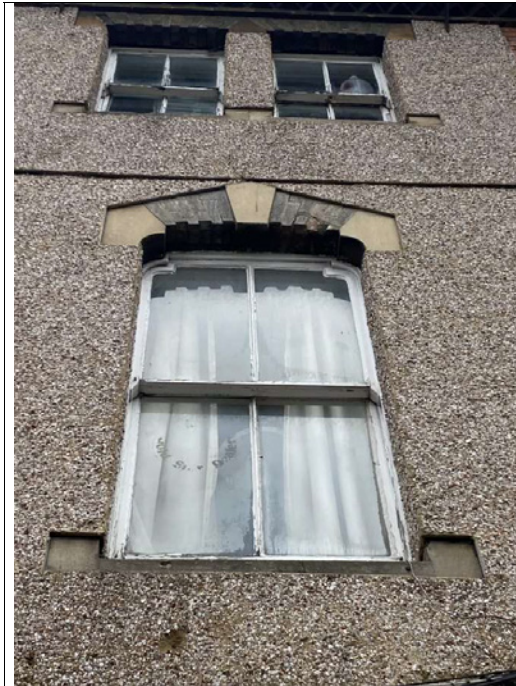
Poor condition of upper floor window. Ornamental lintel details in brick and stone remain visible.

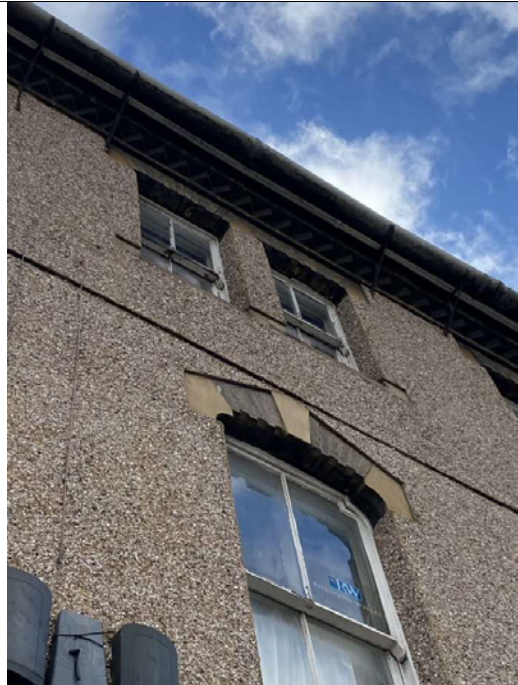
Poor condition of upper floor windows and failing rainwater goods along the roof edge.

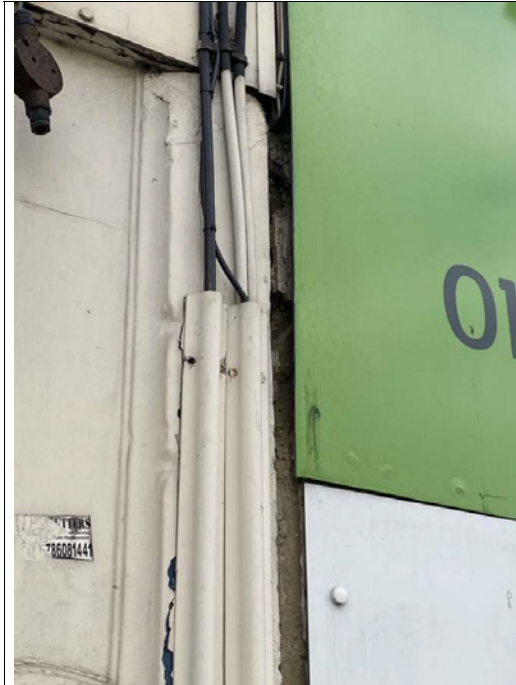
Conduits fixed to adjacent pilaster and some indication that the shopfront façade behind the modern signage is failing.

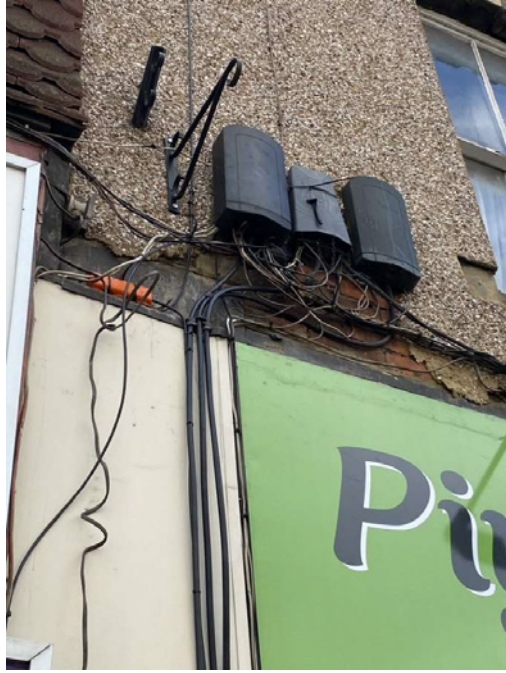
Congested building services and failed textured cement render allowing original brick façade to show through.

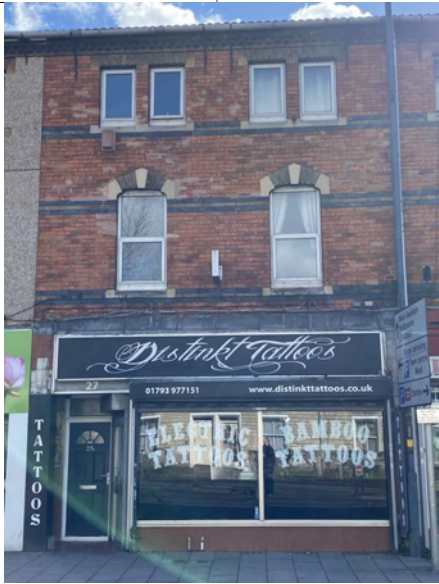
History and significance	Shown on the 1 st edition OS map (1885). The building and terrace as a whole (Nos.25 – 43) have architectural and historic interest, as explained in the summary report ('Faringdon Road, Swindon: A Vision for Shopfront and Façade Enhancements'). Having a much altered façade, there is high potential to enhance the appearance of this property by repairing, revealing and restoring original features. This would also enhance the character and appearance of Swindon's Railway Conservation Area.
Brief Description of Shopfront	Aluminium shopfront. Signage on glazing obscures interior.
Brief Description of Upper Floors	Building forms a group with No. 25-43. Brickwork. Replacement windows.

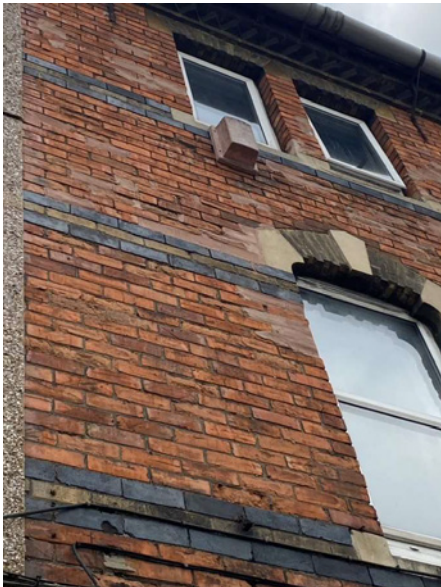
Platched repairs to deteriorated bricks, most likely cause is mortar repointing being too hard.

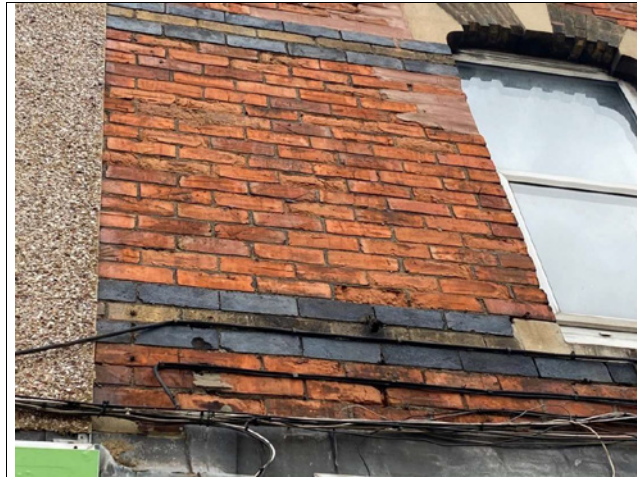
Deteriorating brickwork and congested building services.

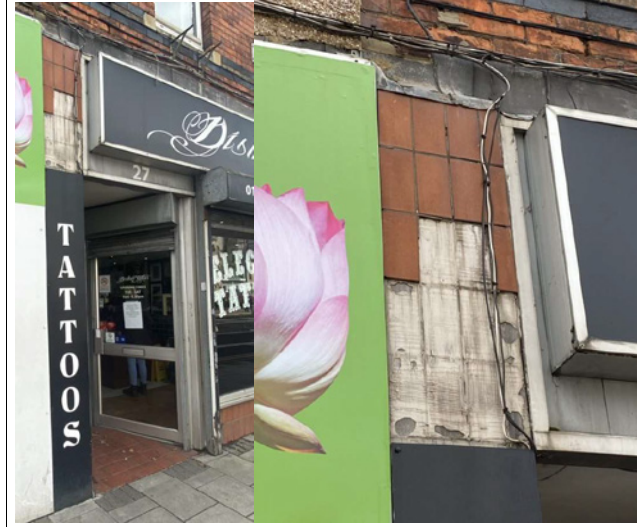
Left: Aluminium-framed shop door and windows with plastic pilaster.
Right: Failed tiling to left side of shopfront, suspected location of original corbel.

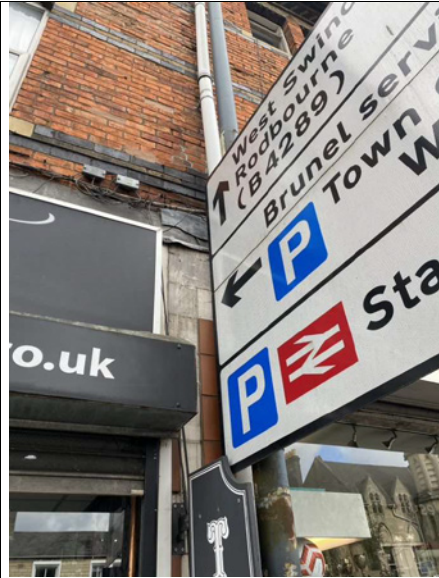
Missing tiles from right side of fascia. Corbel reinstatement would be ideal but this would require moving the highways sign.

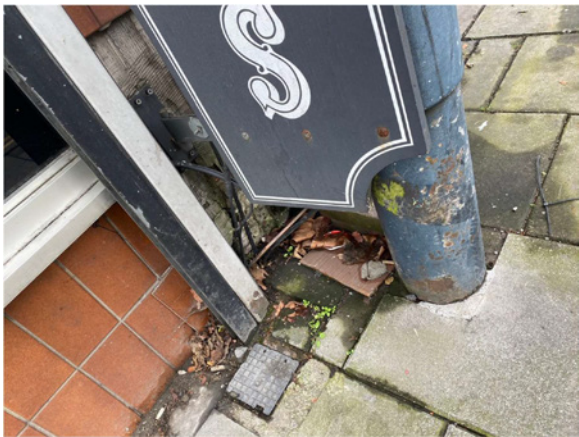
Deteriorated pilaster beside sign and behind lamp post.

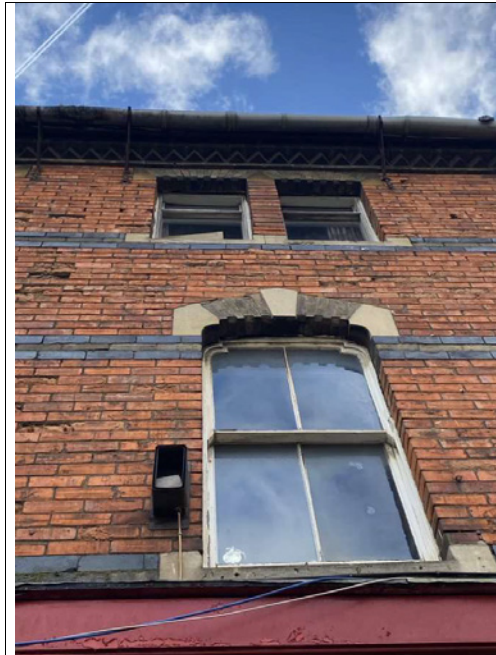
First-floor windows in poor condition. Replacement second-floor windows. Possibly redundant service hardware. However, original features, such as shaped brick lintels, stone cills and decorative bands of blue and buff bricks are intact.

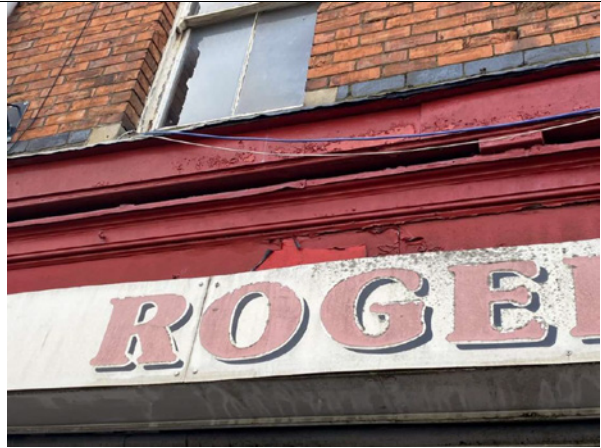
Peeling paint on the shop fascia and hanging wires.

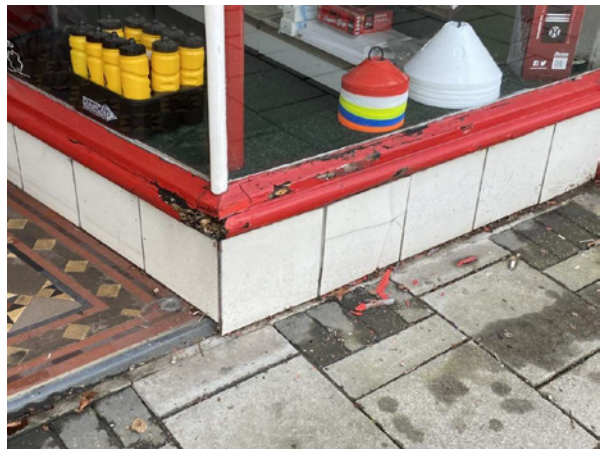
Timber decay to the stallriser nosing detail and a cracked tile.

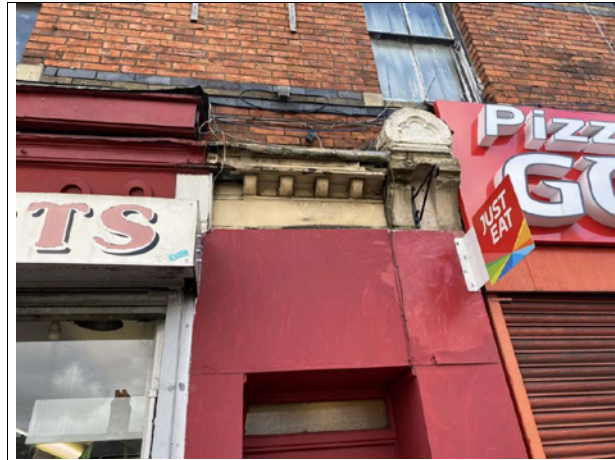
Original dentils and corbel over upper floor entrance door, possible indication that original features are behind timber box hoarding and shop fascia. Redundant hanging bracket. Note the weather covering over the awning is coming away and the timber above the dentils is deteriorating.

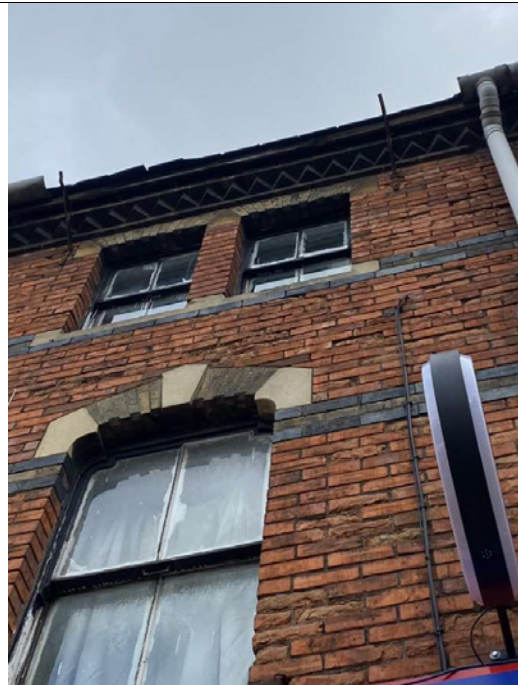
Missing guttering and insecure slates.

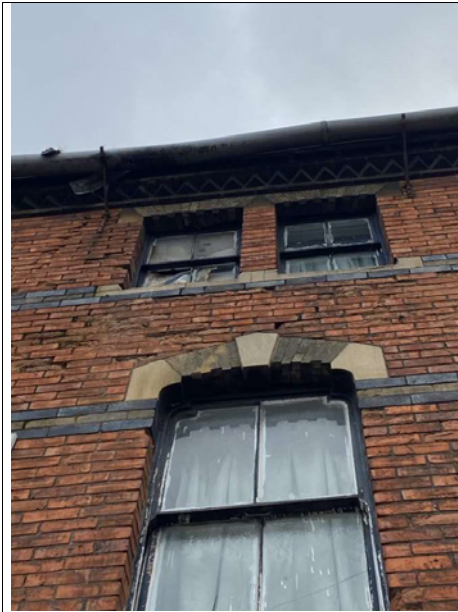
Poor condition of timber windows and broken guttering

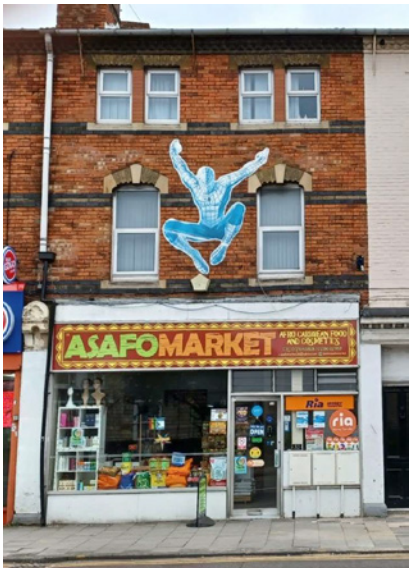
History and Significance:	Shown on the 1 st edition OS map (1885). The building and terrace as a whole (Nos.25 – 43) have architectural and historic interest, as explained in the summary report ('Faringdon Road, Swindon: A Vision for Shopfront and Façade Enhancements'). The shop has some communal value as a supplier of Afro-Caribbean food and cosmetics. Despite the modern windows, the façade above the shopfront makes a positive contribution to the character and appearance of Swindon's Railway Conservation Area. There is high potential to enhance the appearance of this property by repairing, revealing and restoring original features.
Brief Description of Shopfront:	Modern aluminium-framed shopfront.
Brief Description of Upper Floors:	Building forms a group with No. 25-43. Original brickwork and decorative window cills and lintels.

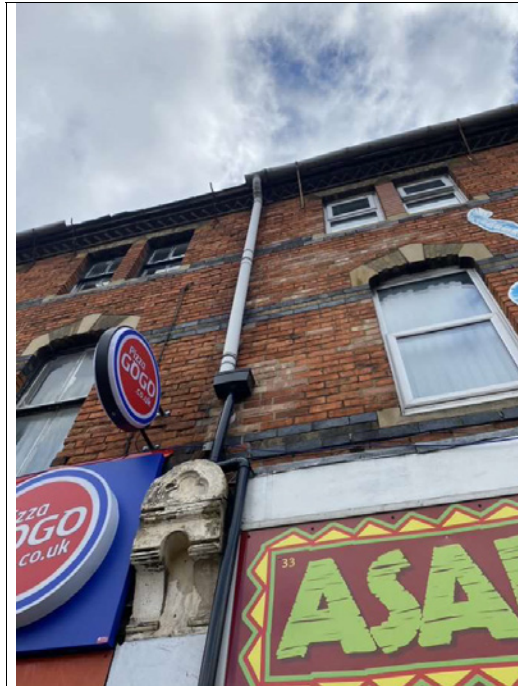
Patch repairs to brickwork visible on upper floors.

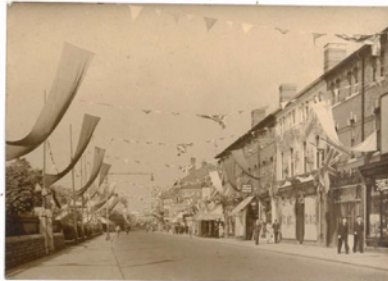
This photo of 1937 shows the façade painted when this property and the adjoining property (No.37) were occupied by Great Western Clothiers).	
Condition of Property	
Roof	Replacement roof covering of concrete tiles.
Facade	1. Paint finish appears in reasonable condition, but it does obscure the condition of the brickwork and decorative features.

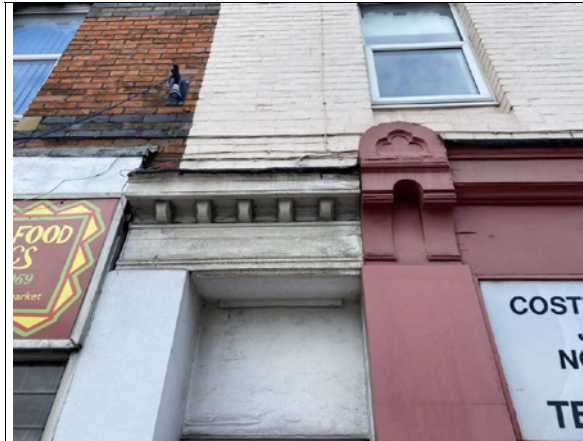
Dentil and corbel features to the left of the shopfront and over door to upper floors. Timber box hoardings covering pilasters.

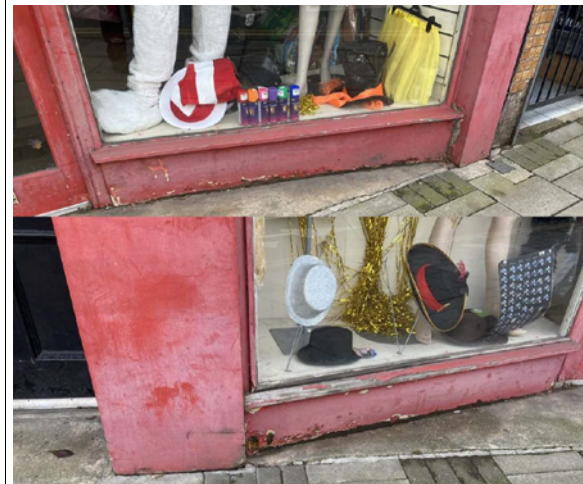
Deterioration to low stallrisers at the shopfront.

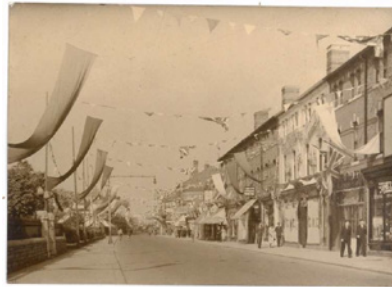
This photo of 1937 shows the façade painted when this property and the adjoining property (No.35) were occupied by Great Western Clothiers.

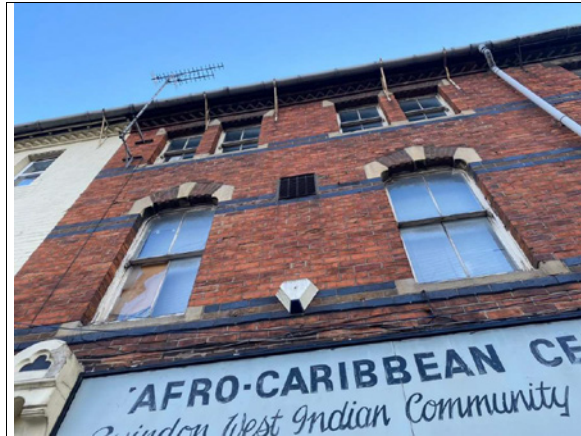
Upper facade showing poor condition of windows, trailing wires, alarm box and large vent between first-floor windows.

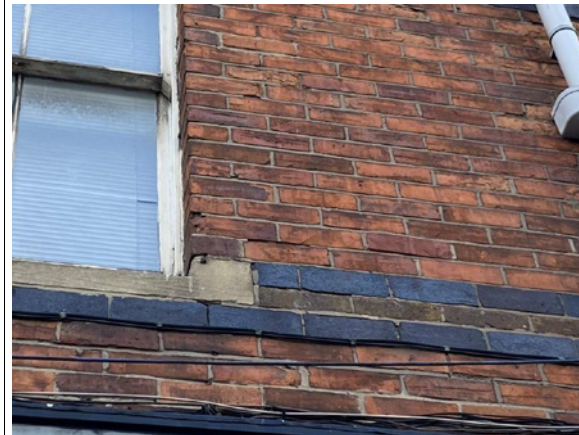
Condition of brickwork on upper levels façade.

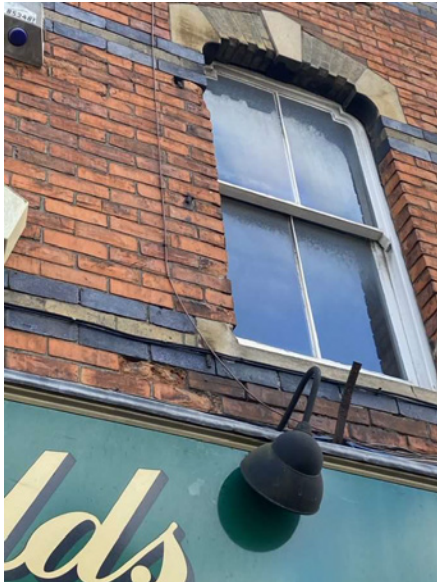
Brick Deterioration and trailing wire to upper façade.

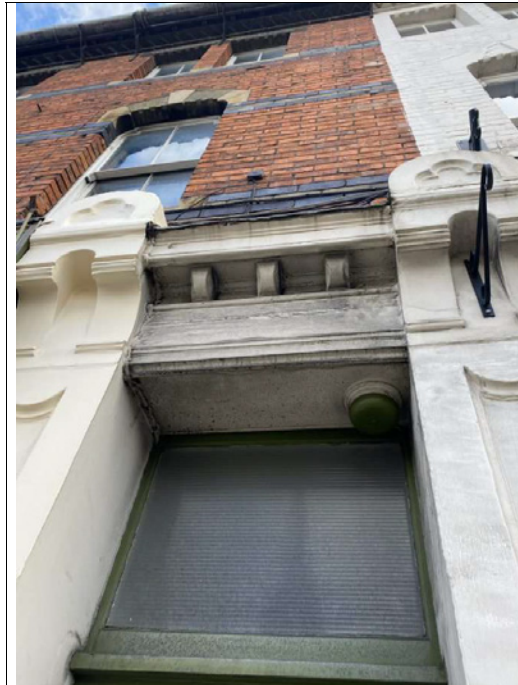
Overhead fascia, dentils and cornice to side door require redecoration.
