Faringdon Road, Swindon
A Vision For Shopfront And Façade Enhancements
Final Report : April 2023

Will Holborow

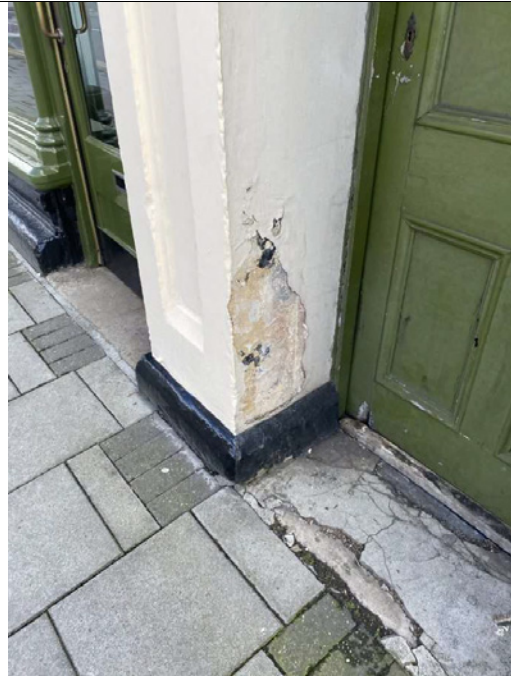
Failing paint at base of pilaster.

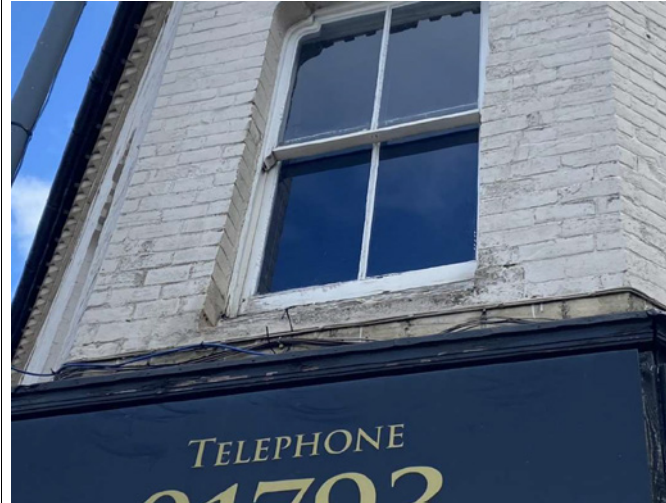
Timber windows to the upper floors, deteriorating paintwork and congestion of wires.

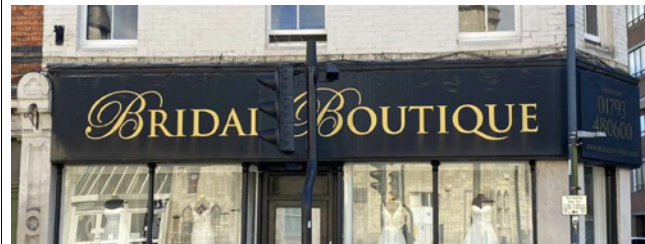
Oversized fascia sign obscures upper part of the original shopfront.

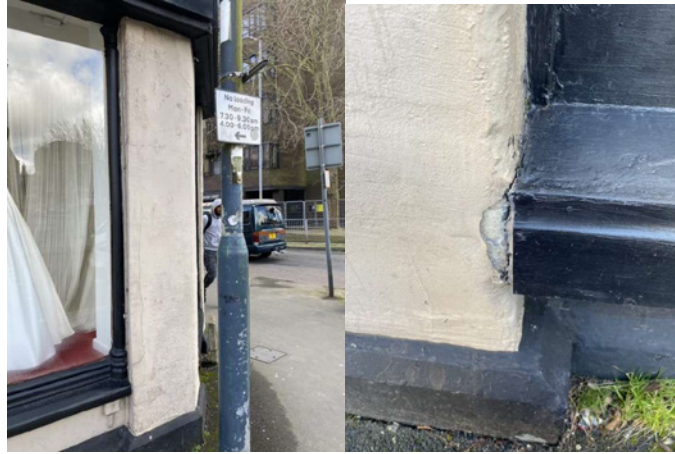
Shopfront pilasters with deteriorating paint.

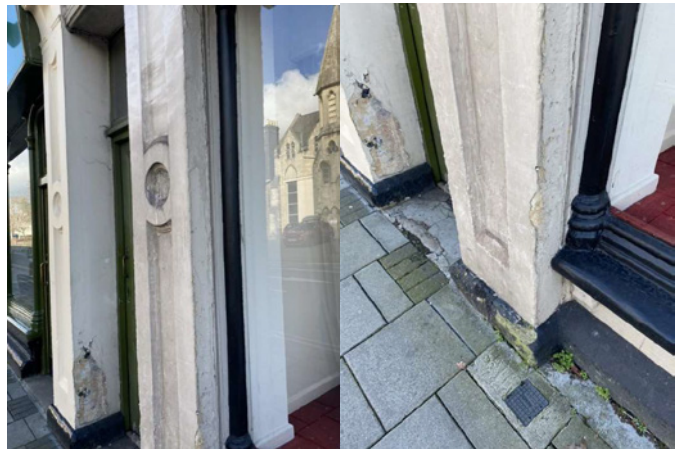
Pilasters in need of redecoration.

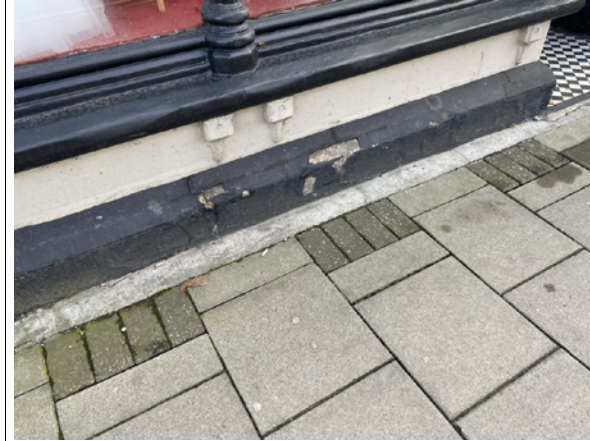
Damage to the nosing on the stallriser.

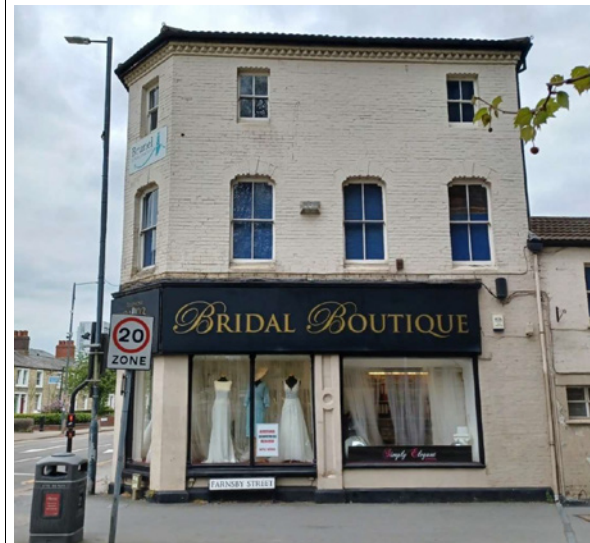
Return elevation to Farnsby Street
